2010-2013 MAZDA3 DAMAGE TO VIN PLATE AND LOWER COWL SHEET METAL

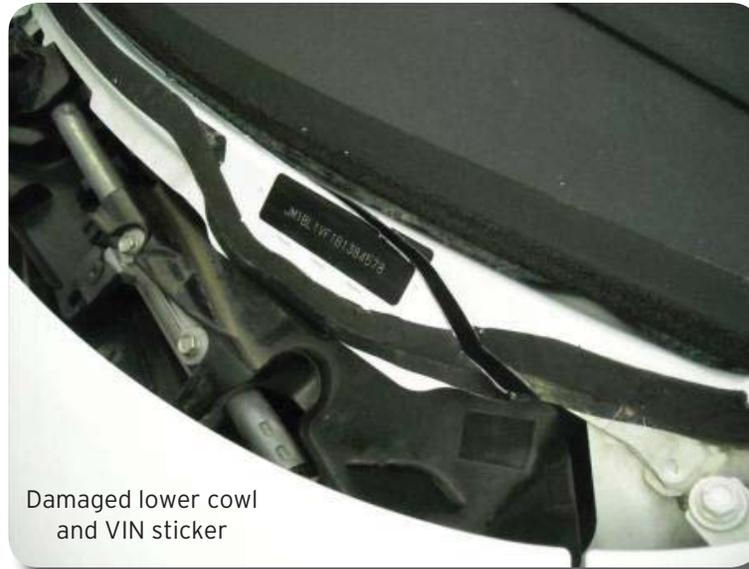
When cutting the urethane prior to removing the windshield, extreme care must be taken to insure that the urethane is completely cut free at the VIN sticker area; otherwise, damage to the lower cowl and VIN sticker may occur.

Damaged lower cowl and VIN sticker

With the windshield installed the technician cannot see this dip and may assume that their tool has cut the urethane, while in fact it may not. As the windshield is then being removed, extreme stress is placed in the subject area and the cowl sheet metal will flex (due to the urethane still adhered to the windshield) and can be split causing damage to the VIN plate without warning.

1. Ensure that all cutting tools are in good working order and sharpened.
2. Use water to lubricate and cool the cutting tool during removal operations
3. With every tool use extra care in the VIN location. The urethane bead dips down 1.5 inches from the top of the VIN Plate and can easily be missed.
4. Do not over flex the windshield to gain access to the lower cowl at the VIN sticker area for a long knife cut out
5. If you encounter resistance when lifting out the windshield DO NOT force it, take the time to locate and cut away any remaining urethane so the glass lifts out easy, especially in the VIN location
6. Piano wire or a long knife are the preferred tools to use in the cowl area of these vehicles, especially in the VIN sticker area, however caution must be used to not inadvertently cut the single layer of sheet metal that the VIN is attached to.

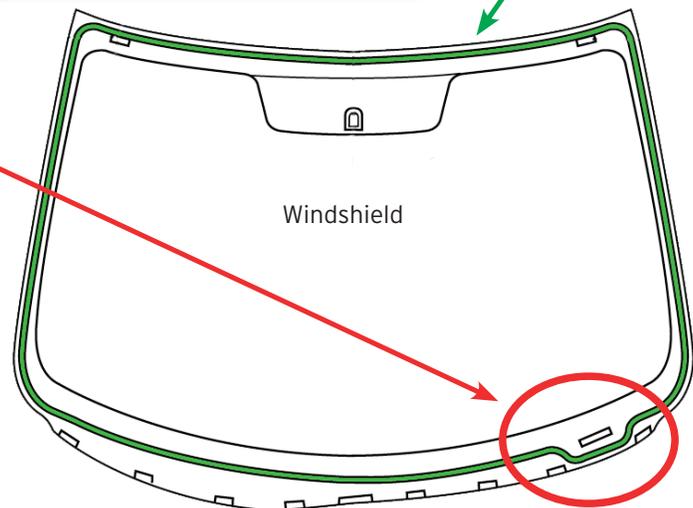
Urethane sealer is shown as green.

The urethane pattern dips downwards at the VIN sticker location.

Use the following guideline to prevent damage to the lower cowl and VIN sticker.
